USER MANUAL
DRY CARGO
BREAK BULK
CARRIER

RAPID
RESPONSE
DAMAGE
ASSESSMENT

September 2019

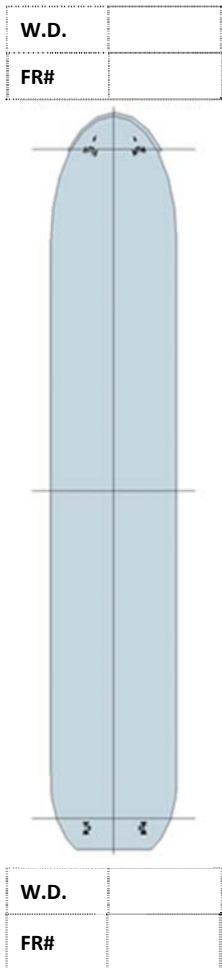
Vessel Name:			
Date:			
1. Drafts - Aground			
Units	Meters	Feet	
Time	-hrs.	Local	UTC
--	Forward	Amidships	Aft
Port			
Starboard			
List or Heel		Degrees	P S
2. Approximate Area of Ground Contact			
Outline the approx. contact area on the hull outline.			
3. Provide water depths (W.D.)			
Water depth values to the extent needed.			
Measured by a boat or tug?			
Measured from ship's deck?			
4. Vessel Heading			
			-Degrees (T)

W.D.			
FR#			
W.D.		W.D.	
FR#		FR#	
W.D.		W.D.	
FR#		FR#	
W.D.		W.D.	
FR#		FR#	
W.D.		W.D.	
FR#		FR#	
W.D.		W.D.	
FR#		FR#

The diagram shows a vertical hull outline with a central vertical line. At the top and bottom, there are small horizontal lines with arrows pointing outwards, indicating measurement points. The diagram is surrounded by a grid of data entry boxes for water depth (W.D.) and frame number (FR#).
